APOLLO 13 MISSION  
HIGH-GAIN ANTENNA ACQUISITION PROBLEM

ANOMALY REPORT 2

December 1970

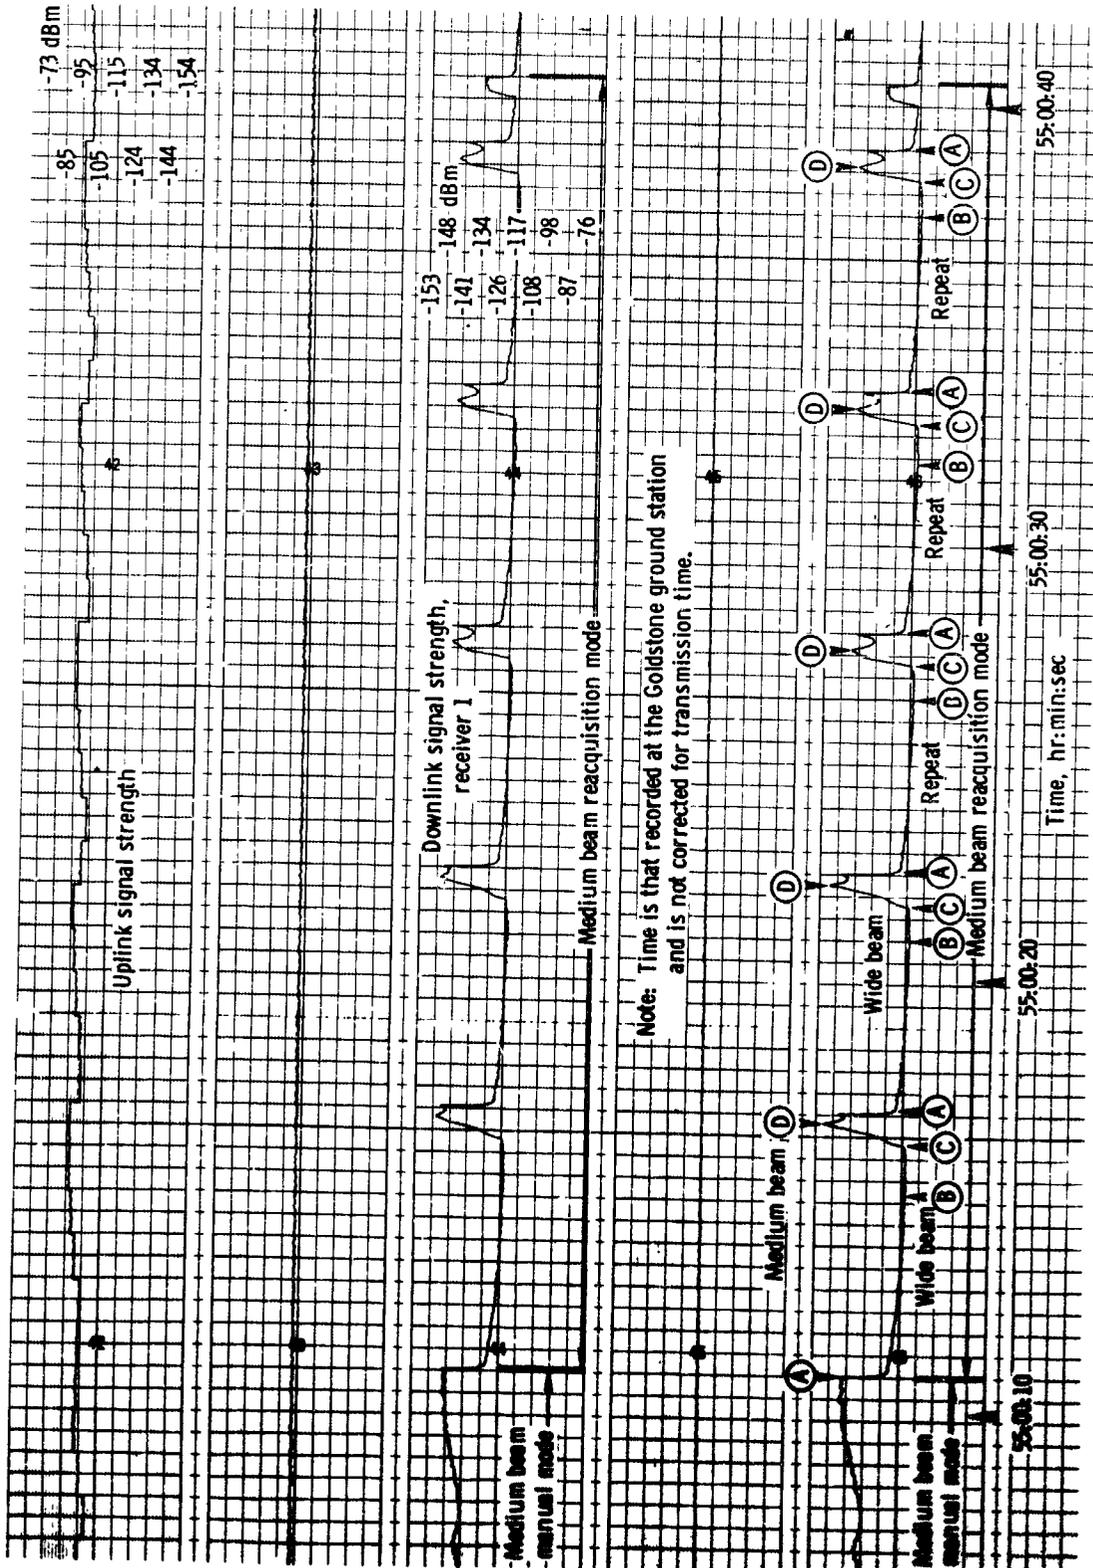
Figure 1.- Recorded signal strengths during high gain antenna operation.

At 55:00:10, the reacquisition mode was selected. Starting at 55:00:10 and continuing to 55:00:40, deep repetitive transients were noted approximately every 5 seconds on the phase-modulated downlink carrier and the antenna would not lock up and track.

At the time of the anomaly, the antenna boresight axis was approximately  $35^\circ$  away from the line-of-sight to the ground station because, 7 hours earlier, the Command Module Pilot had manually adjusted the antenna to the ground-requested settings of plus  $23^\circ$  in pitch and  $267^\circ$  in yaw. The most favorable settings for 55 hours were actually plus  $5^\circ$  in pitch and  $237^\circ$  in yaw. When the transmission was switched from the omnidirectional antenna to the manual mode of the high-gain antenna, there was a 6-dB decrease in uplink signal strength and a 17-dB decrease in downlink signal strength. With the high-gain antenna in the wide-beam mode and nearly boresighted, the uplink and downlink signal strengths should have been at least equal to the signal strength obtained with the omnidirectional antenna. A comparison of the wide-, medium-, and narrow-beam transmit and receive patterns indicates that the high-gain antenna was in the medium-beam, manual mode at the time of acquisition and remained in this configuration until the reacquisition mode was selected at 55:00:10. Starting at 55:00:10 and continuing to 55:00:40, deep repetitive transients occurring approximately every 5 seconds were noted on the phase-modulated downlink carrier (fig. 1).

The antenna functions which caused the cyclic inflight RF signatures resulting from a shift in the function lines can be explained with the aid of figures 1 and 2, with the letters A, B, C, and D corresponding to events during the cycle. Starting at approximately 55:00:10, the antenna was switched from manual to auto reacquisition with the beam select switch in the medium-beam position. From point A to the scan-limit function line just prior to point B, the antenna acquired the earth in wide beam. When the antenna reached the scan-limit function line, the antenna control logic switched the system to the manual mode and drove back toward the manual settings until the scan-limit-warning function line at point C was reached, thereby maintaining wide-beam operation. When the antenna reached the scan-limit-warning function line, the system automatically switched to the medium-beam mode and continued to drive in the manual mode until the manual setting error was nulled out at point A. The antenna control logic then switched to the auto-track mode and repeated the cycle. The most important feature of this cycle is that the antenna moved at the manual scan rate between points B and D, which is confirmed by the rapid changes in the downlink signal strength.

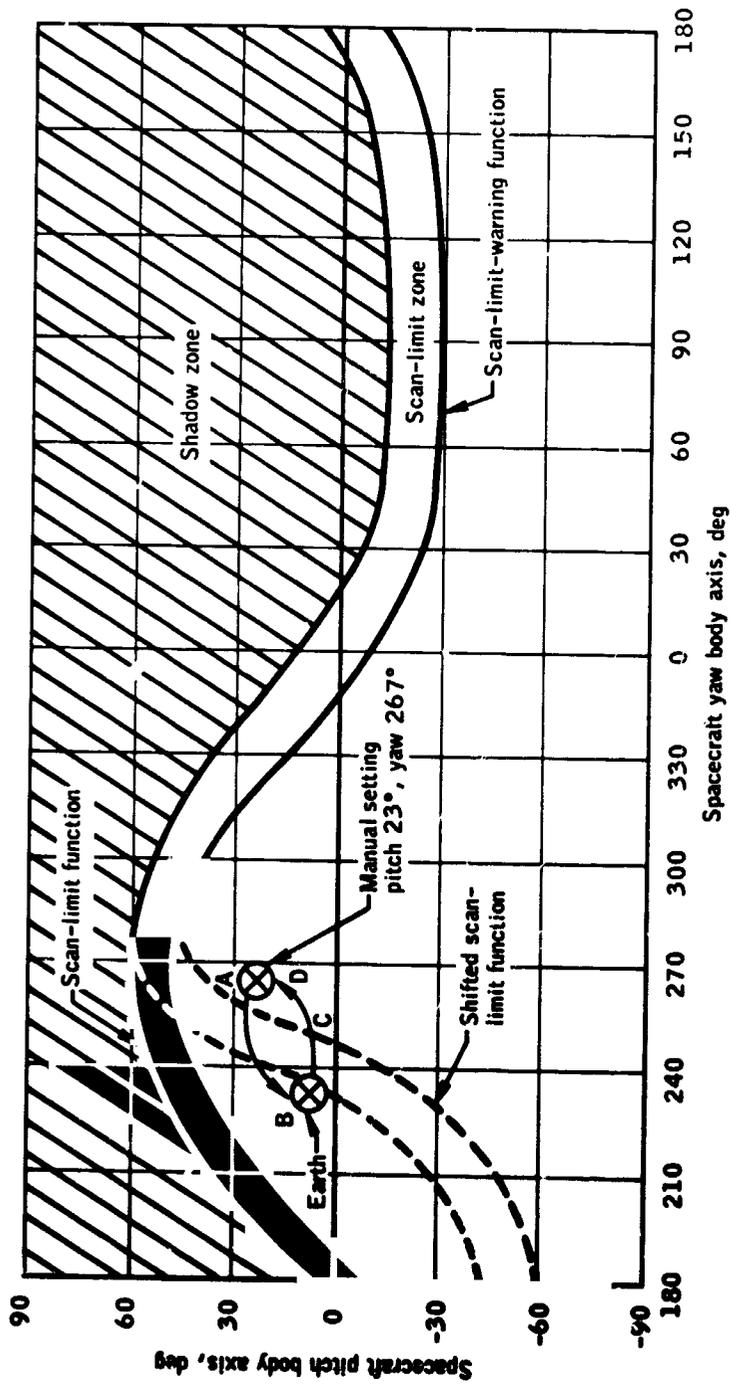
Figure 2.- Shift in scan-limit and scan-limit-warning function lines.

Most probably, a short occurred in the primary winding of the C-axis induction potentiometer which resulted in an effective shift in the scan-limit and scan-limit-warning functions.

Tests have been added at the launch site to ensure proper scan-limit and scan-limit-warning functions prior to flight. In addition, a procedure has been developed to determine acceptable spacecraft attitudes for high-gain antenna operation in the event another scan-limit shift occurs on a future flight.
